Very-Low Pin-Hole-Density SiN_x Film Deposited at 300 C using Unaxis HDPCVD Tool

Purpose: One of our external customers requested us to grow a high quality SiO₂ (1 μm)/SiN_x (0.2 μm)/SiO₂ (1 μm)/SiN_x (0.2 μm) multi-layer film on a Cr-patterned Si wafer using our Unaxis high-density-plasma CVD (HDPCVD) tool for him. This Unaxis deposition tool is partially different from a conventional PECVD tool by the facts that (1) the wafer chuck is severed as a cathode so that, during the deposition run, the ions in the plasma bombard the wafer surface which can cause pin-holes in the growing film if the bias power is too high; (2) Intrinsically, the stress of the SiN_x is very high, resulting in a crack film under a small bias power, *e.g.*, ~1.8 GPa in compression at a bias power of 5 W and a chuck temperature of 250 C, and the only way to reduce the stress is to apply a higher bias. So, there is a conflict of interest between a low stress and a low pin-hole density of the SiN_x film deposited using this tool. Here, to meet this customer's need, it is required to find a compromised bias power, under which the SiN_x film is not crack and is pin-hole free.

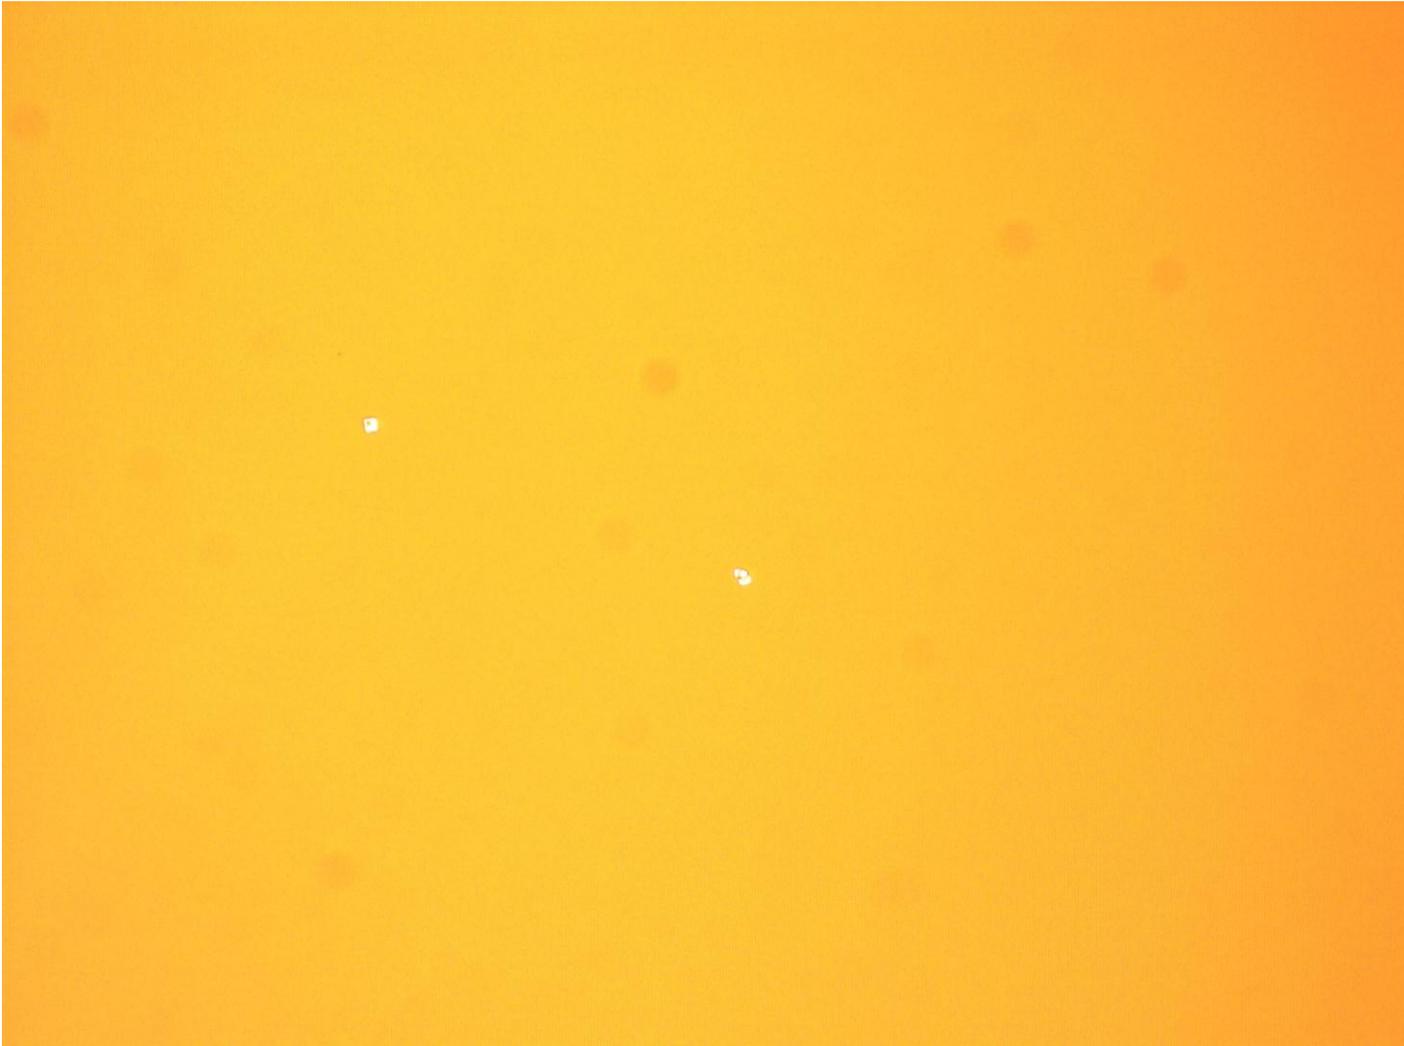
Figure 1 Pin-hole test result after the SiN_x film (1944 Å in thickness) wafer being in the hot (90 °C) KOH for 32.5 minutes. Note: there are some pin-holes in the film, which were caused by some small particles on the test-graded Si wafer prior to the deposition.

- 1) Deposition Rate=212 Å/min;
- 2) Reflective Index=2.01;
- 3) Buffered HF Etch Rate=400 Å/min;
- 4) Film Stress (at a thickness of 1944 Å) =-893 MPa.
- 5) Pin-Hole test was carried out with the film wafer being soaked in a heated KOH at 90 C for 32.5 minutes. The result shows (see Figure 1) there is almost no pin-hole in the film.

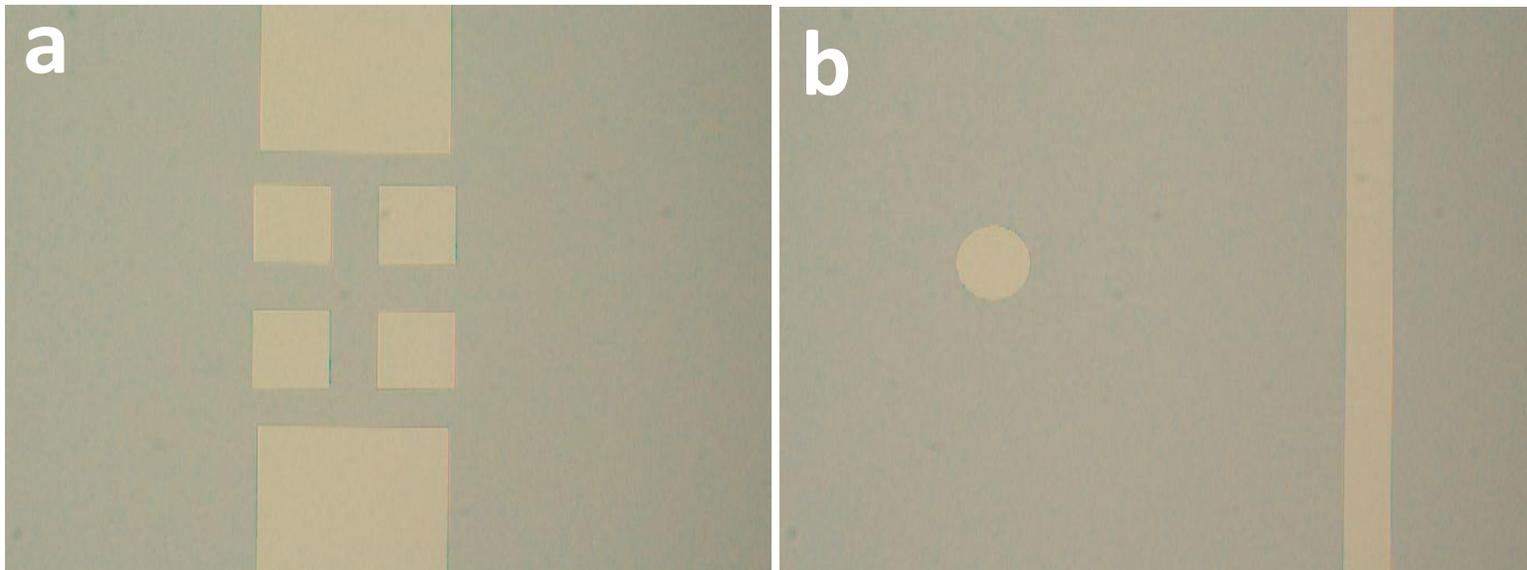
Figure 2 (a) and (b) Microscopic pictures of the SiO_2 (1 μm)/ Si_3N_4 (0.2 μm)/ SiO_2 (1 μm)/ Si_3N_4 (0.2 μm) multi-layer film, deposited using Unaxis HDPCVD tool at a chuck temperature of 300 $^\circ\text{C}$ on the customer's Cr-patterned wafer. The deposition condition of Si_3N_4 was 15mT, 25/400W, $\text{SiH}_4/\text{N}_2/\text{He}/\text{Ar}$ flow-rate=7.2/4/350/20 SCCM, and time=566 seconds; the deposition condition of SiO_2 was 5mT, 15/800W, $\text{SiH}_4/\text{O}_2/\text{Ar}$ flow-rate=27.5/55/20 SCCM, and time=540 seconds.

Next thing was to grow a SiO_2 (1 μm)/ Si_3N_4 (0.2 μm)/ SiO_2 (1 μm)/ Si_3N_4 (0.2 μm) multi-layer film on the customer-supplied Cr-patterned Si wafer. The deposition sequence was 1) cleaning the process-module-3 (PM3) deposition chamber with $\text{SF}_6/\text{O}_2/\text{Ar}$ plasma and doing SiO_2 chamber season; 2) transferring the customer's wafer from load-module (LM) to the PM3 and growing the first SiO_2 and Si_3N_4 layers, then, transferring the wafer from PM3 to LM (LM was still under a lower vacuum); 3) cleaning PM3 and doing SiO_2 chamber season again; 4) transferring the wafer from LM to PM3 and growing the second SiO_2 and Si_3N_4 layers. The result (see Figure 2) shows the film is good: there is no cracking in the film.
